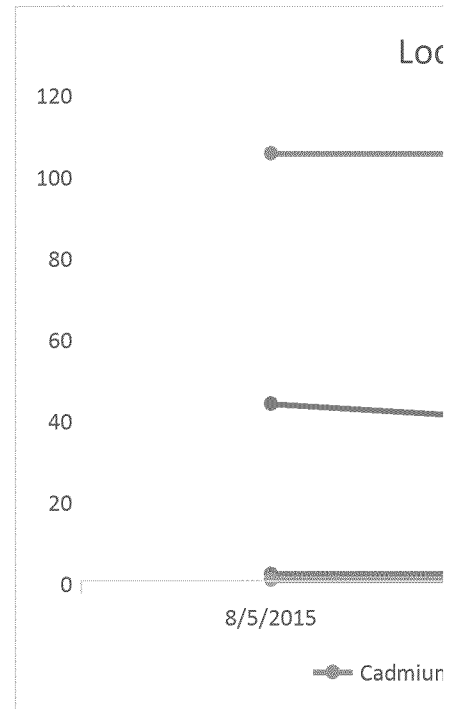
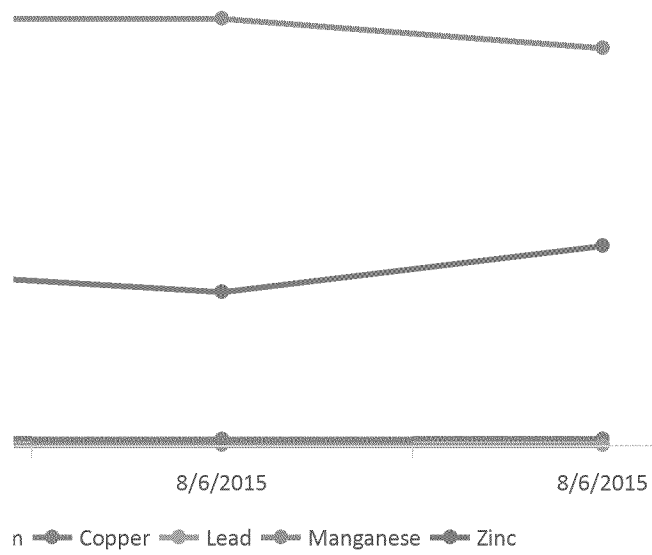
Location: 32nd Street Bridge

ocation ID	Date Sampled	Cadmium	Copper	Lead	Manganese	Zinc
32nd St Br	8/5/2015	0.178	1.7	0.24	105	43.5
32nd St Br	8/6/2015	0.16	1.56		105	37.8
32nd St Br	8/6/2015	0.19	1.62	0.115	97.8	49.1

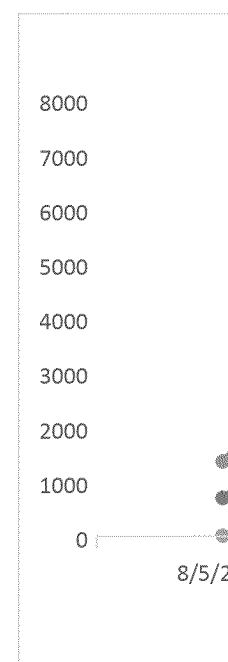
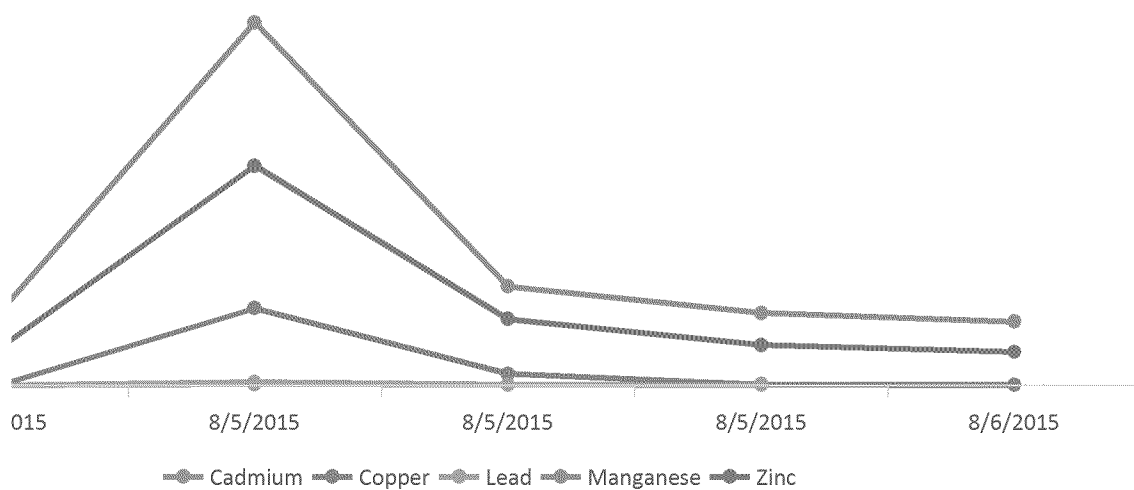
Location: A72

Location ID	De Sampled	Cadmium	Copper	Lead	Manganese	Zinc
A72	8/5/2015	1.81	9.27	0.225	1370	699
A72	8/5/2015	15.2	1410	50.7	6650	4020
A72	8/5/2015	4.29	205	3.12	1810	1210
A72	8/5/2015	2.59	11.4	0.118	1320	733
A72	8/6/2015	2.11	7.63		1160	609

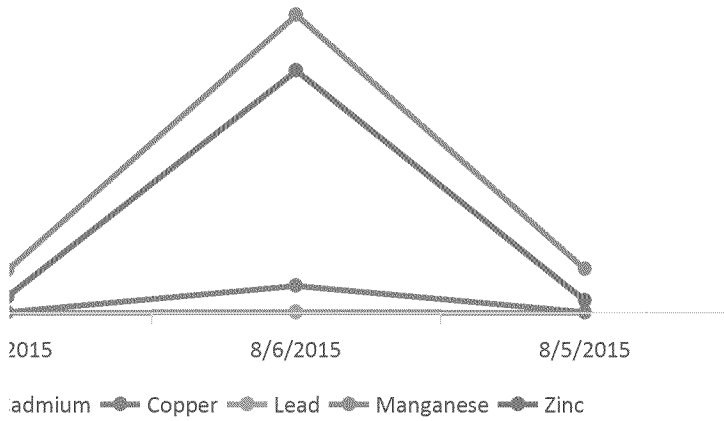
Location: Bakers Bridge

ocation ID	De Sampled	Cadmium	Copper	Lead	Manganes	Zinc
Bakers Bri	8/6/2015	0.336	1.88		296	110
Bakers Bri	8/6/2015	5.32	189	1.56	2090	1700
Bakers Bri	8/5/2015	0.353	2.28		306	85.8

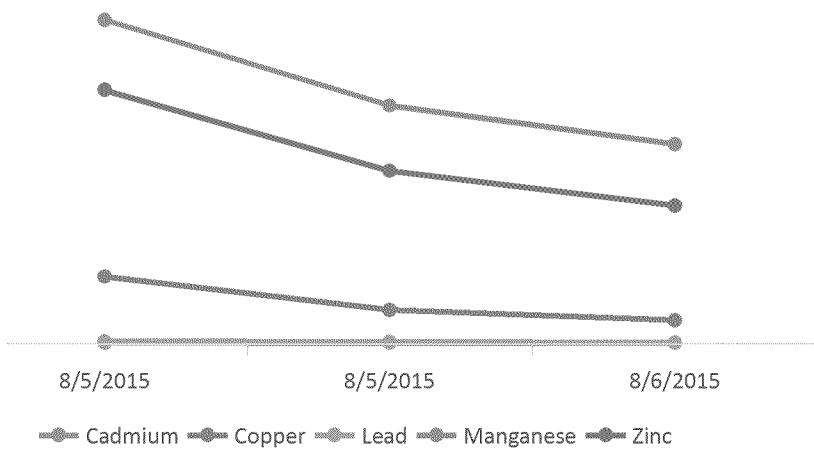
Location: CC48

ocation ID	Sampled	Cadmium	Copper	Lead	Manganese	Zinc
CC48	8/5/2015	30.6	2260	73.9	10900	8540
CC48	8/5/2015	19.1	1130	54.1	8020	5820
CC48	8/6/2015	14.2	786	30	6720	4650
